REPORT OF THE 14 MAY 2014 ACCIDENT AT THE KUDANKULAM NUCLEAR POWER PLANT

VT Padmanabhan,* R. Ramesh, V Pugazhendi,
Raminder Kaur, Joseph Makolil

Summary

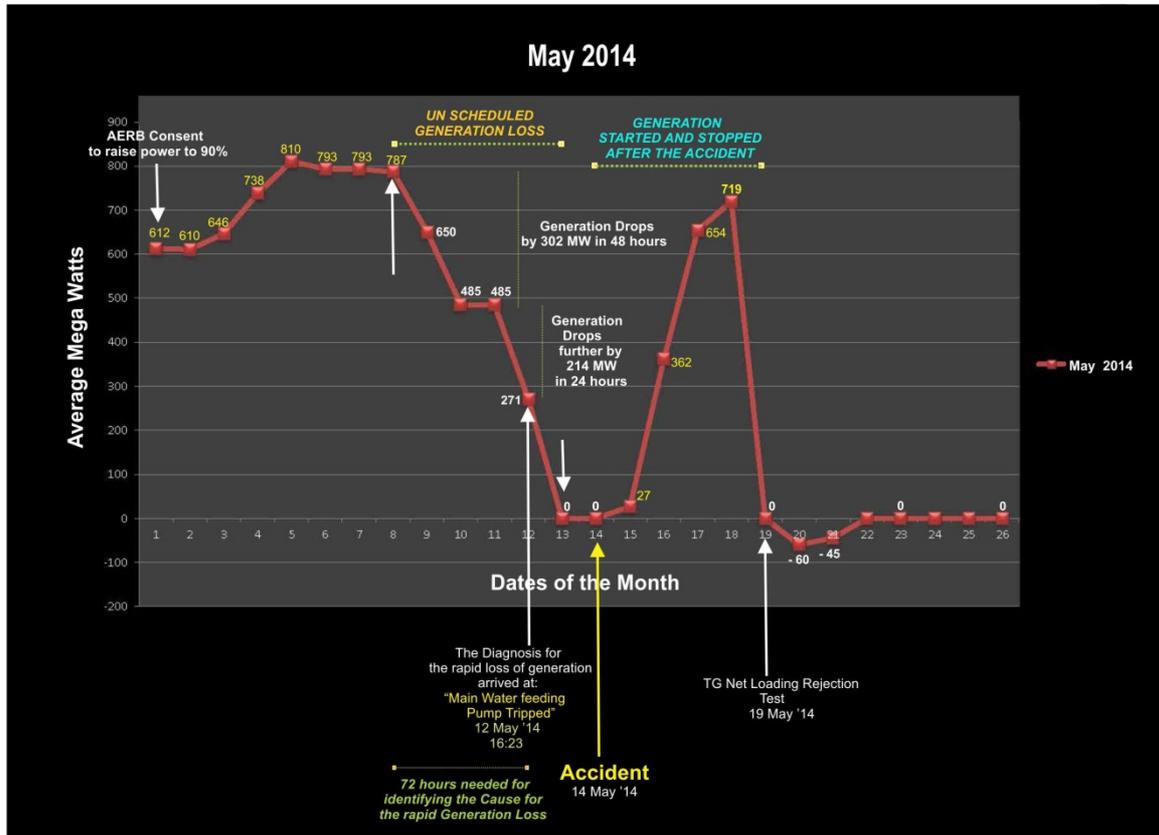
KKNPP One - Generation before and after the Accident on 14 May 2014

Graph- 1: Daily data on average generation (MWe) and important events at KKNPP- 01 to 26 May 14.

Table 1 has data on day's peak generation and million units delivered during the period 08 May to 02 June 2014. Chart-1 is based on data of average MW(e) per day for the period 01 May to 26 May. Column 4 in table 1 shows the time of outage (left aligned) and time of revival (right aligned). The reactor was on a forced shut down since 14.36 on 12 May 14 due to the problems in the main feed-water pump.⁵

The reactor remained off-grid till 16.23 on 15 May. A Press Trust of India (PTI) dispatch, filed at 14.55 on 14 May quotes the Station Director saying that the “Reactor No.1 attained criticality again today morning and continued to operate at low reactor power level. Steam supply to turbine and subsequent synchronization to the grid was planned for tomorrow”⁶. So at the time of the accident, the operators were trying to raise the power level and run the turbine. The reactor was *not under maintenance shutdown* and the workers were *not repairing* any valve.

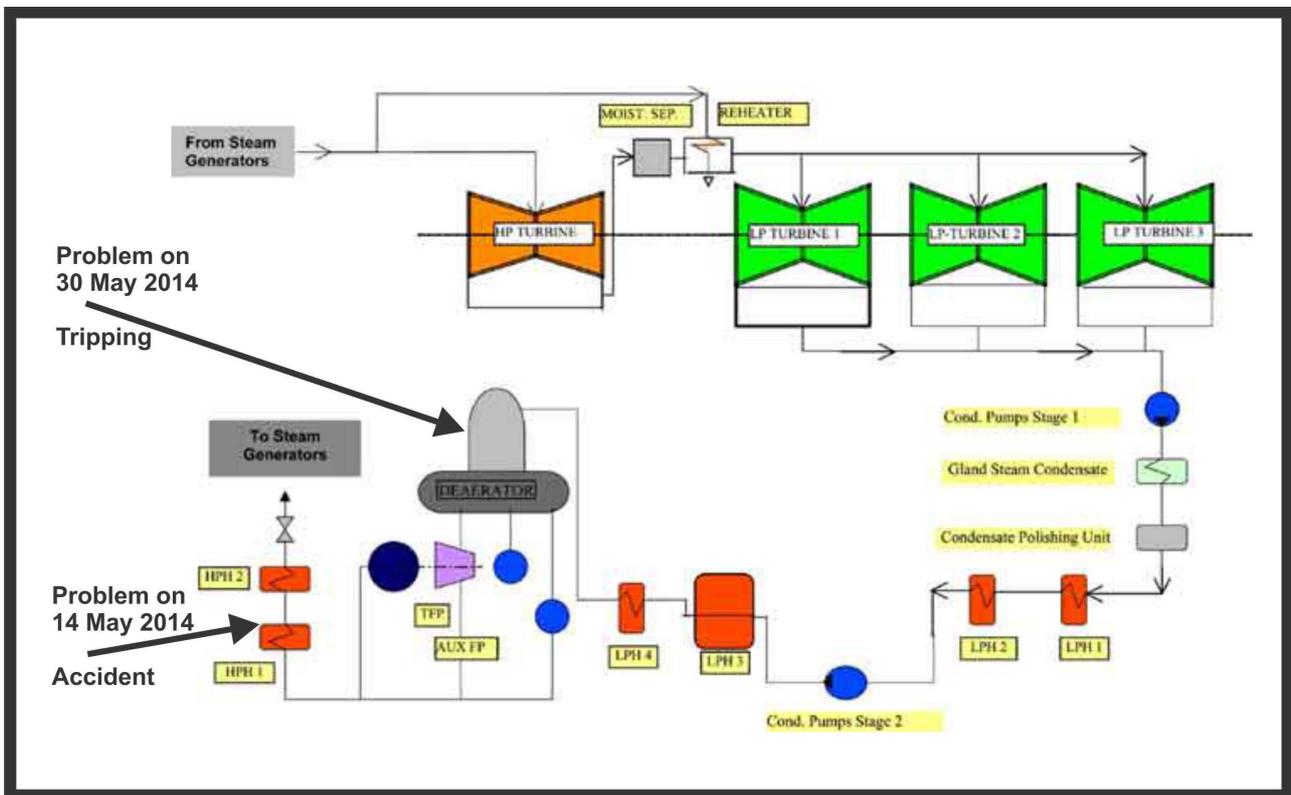
Figure-1 : Flow chart Feed-water system of KKNPP

Before the 14 May accident, there were two events (on 29 Oct 2013⁸ and 12 May 2014⁹) related to feed-water system, leading to the shutdown of the reactor for 9 days. Another event on 30 May due to problems in the deareator, located on the feed-water system just before the spot of 14 May accident, took the reactor off line for 4 days. (See figure-1) Again, four days after this accident, there was another outage, lasting for 8 days.¹⁰ The cause of this outage, according to SRLDC was net load rejection test. Load rejection test can only be conducted when the generator is grid connected and this test is completed in a few hours. So the actual cause of this outage remains unknown. Most probably the machine might have tripped while they were undertaking this test. On 7th June, the reactor achieved its much-awaited milestone of 1000 MW(e)(e) and stayed stable around this mark for three days. Again at 18.27 hrs on 10 June, the reactor tripped due to control system, heralding the fifth interruption of the C-3 commissioning tests. Part-2 of this study based on an analysis of SRLDC's generation and outage data since the generator's grid connection reveals
