# Wiring of a Jaycar null model cable: first results

## Abstract:

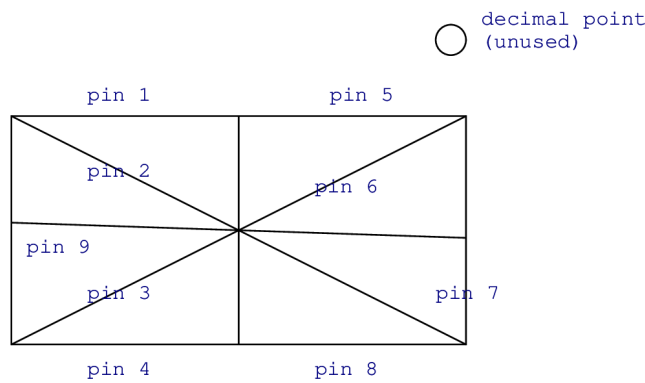
This diagram should clarify things (sorry, I know that the middle “horizontal” line is not perfectly horizontal, but I didn’t have the patience to try to draw a very good quality diagram):

The associated breadboard traces were too badly damaged (overheated during soldering I think) for me to continue using the associated segments, so I had to change the mapping of DB9 connector pins to display segments to get around the problem. The new mapping is:

So now each pin corresponds to exactly one display segment for all pins.
