REPORT OF THE 14 MAY 2014 ACCIDENT AT THE KUDANKULAM NUCLEAR POWER PLANT

VT Padmanabhan,* R. Ramesh, V Pugazhendi,
Raminder Kaur, Joseph Makolil

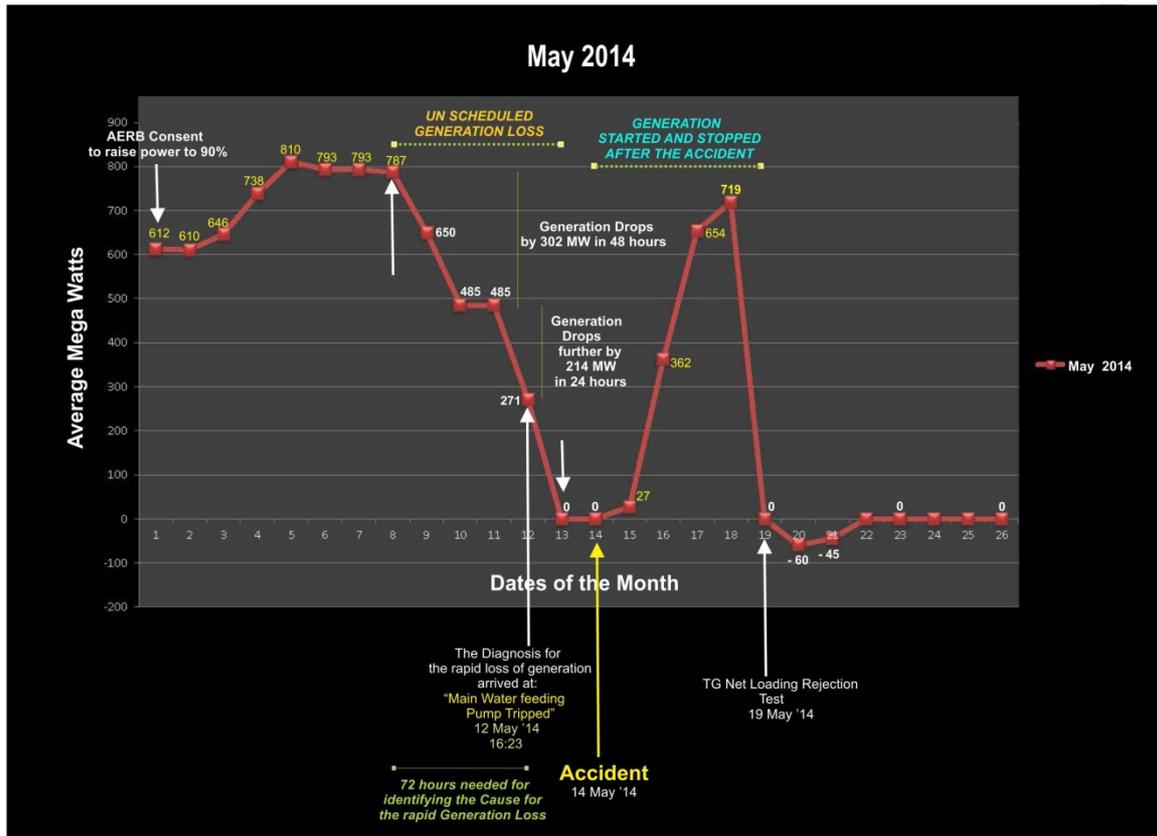
KKNPP One - Generation before and after the Accident on 14 May 2014

The daily data on output and the time of outage and revival as per SRLDC for the period 08 May to 03 June 1014 are given in table 1 and in chart 1 below. The reactor was on a forced shut down since 14.36 on 12 May 14 due to the problems in the main feed-water pump. During this period there were four events and three outages. The times of outage and revival are given in column 4.

The reactor remained off-grid till 16.23 on 15 May. In a Press Trust of India (PTI) dispatch, filed at 14.55 on 14 May, the Station Director said that “Reactor No.1 attained criticality again today morning and continued to operate at low reactor power level. Steam supply to turbine and subsequent synchronization to the grid was planned for tomorrow”⁵. So at the time of the accident, the operators were trying to raise the power level and run the turbine. The reactor was *not under maintenance shutdown* and the workers were *not repairing* any valve.

The 14 May accident took place in the very sub-system that tripped on 12 May. As the reactor attained criticality in the morning, the entire commissioning team and the cameras would have been focusing on the pump that tripped and other vulnerable points within the feed-water subsystem.
